DURABILITY INVESTIGATION OF A ONE-QUARTER-SECTOR  
COMBUSTOR AT HIGH VALUES OF INLET-AIR  
PRESSURE AND TEMPERATURE

By Jerrold D. Wear

Lewis Research Center  
Cleveland, Ohio

June 1960

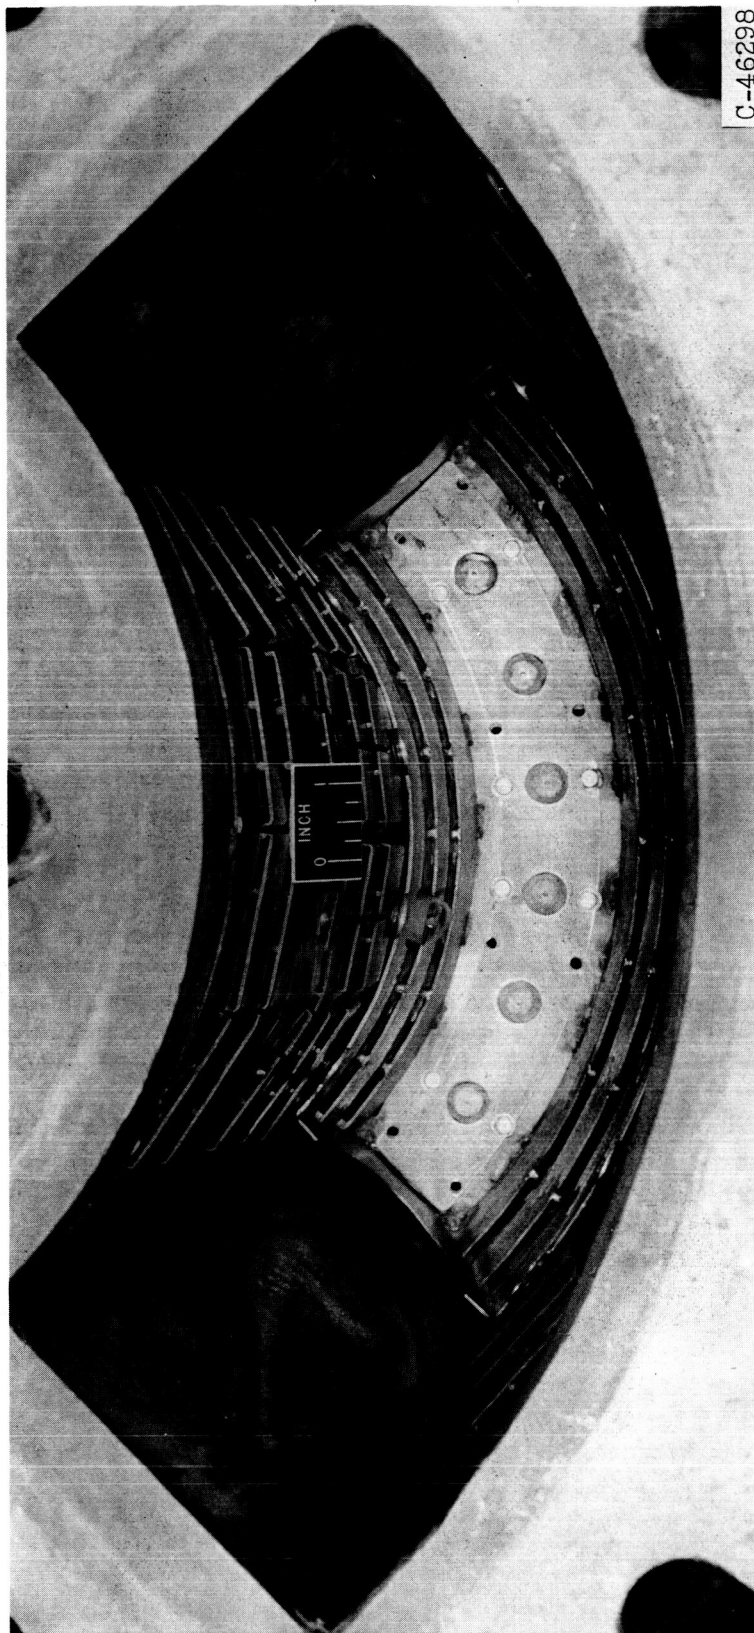
(a) Pilot section and short-radius or top channels.

Figure 5. - Pilot section and channels in housing, showing condition before start of test program.  
View looking upstream toward fuel nozzles.

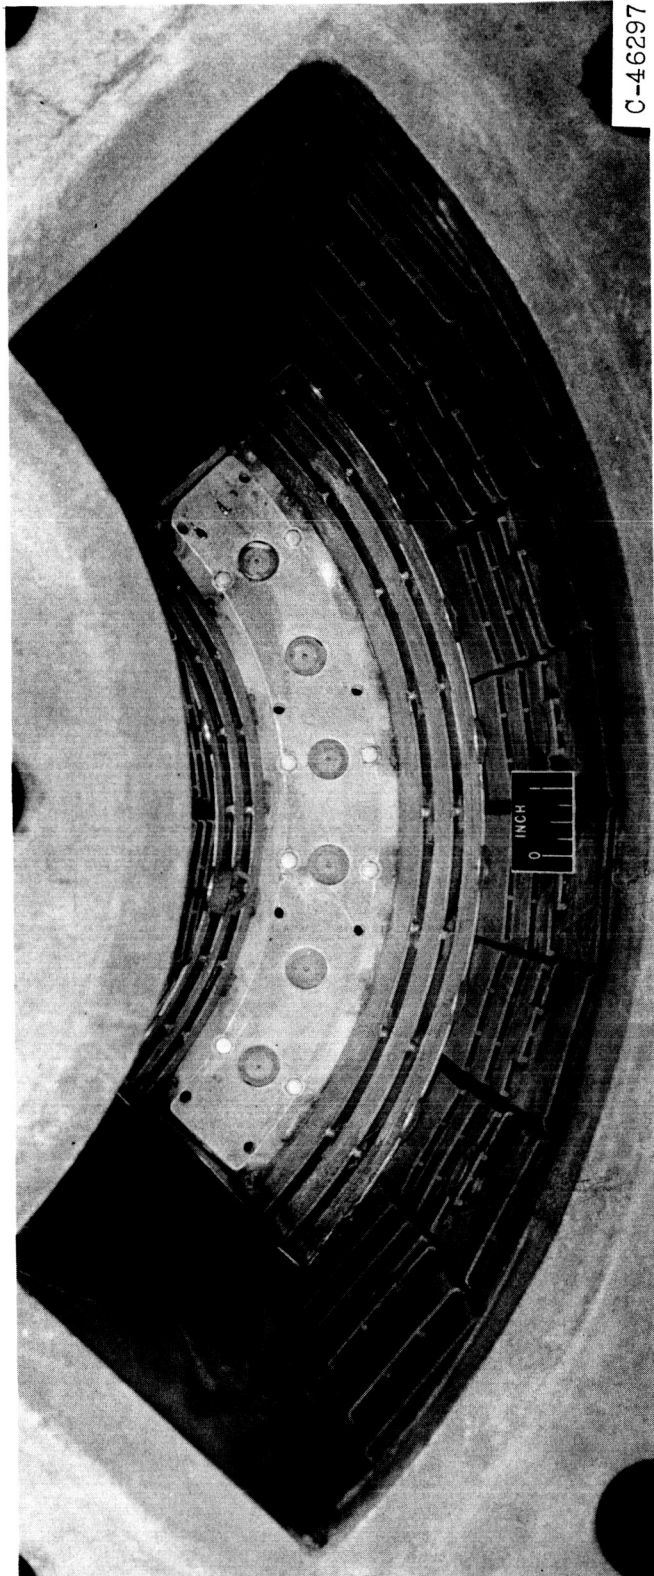
(b) Pilot section and long-radius or bottom channels.

Figure 5. - Concluded. Pilot section and channels in housing, showing condition before start of test program. View looking upstream toward fuel nozzles.
